the **Parker** company

SUBJECT: Hooker Chemicals and Plastics, Morenci
RCRA AND ACT 64 VIOLATIONS

Staff Report

Occidental Chemical Corporation
Parker Surface Treatment Products Division
322 Main Street
Morenci, Michigan

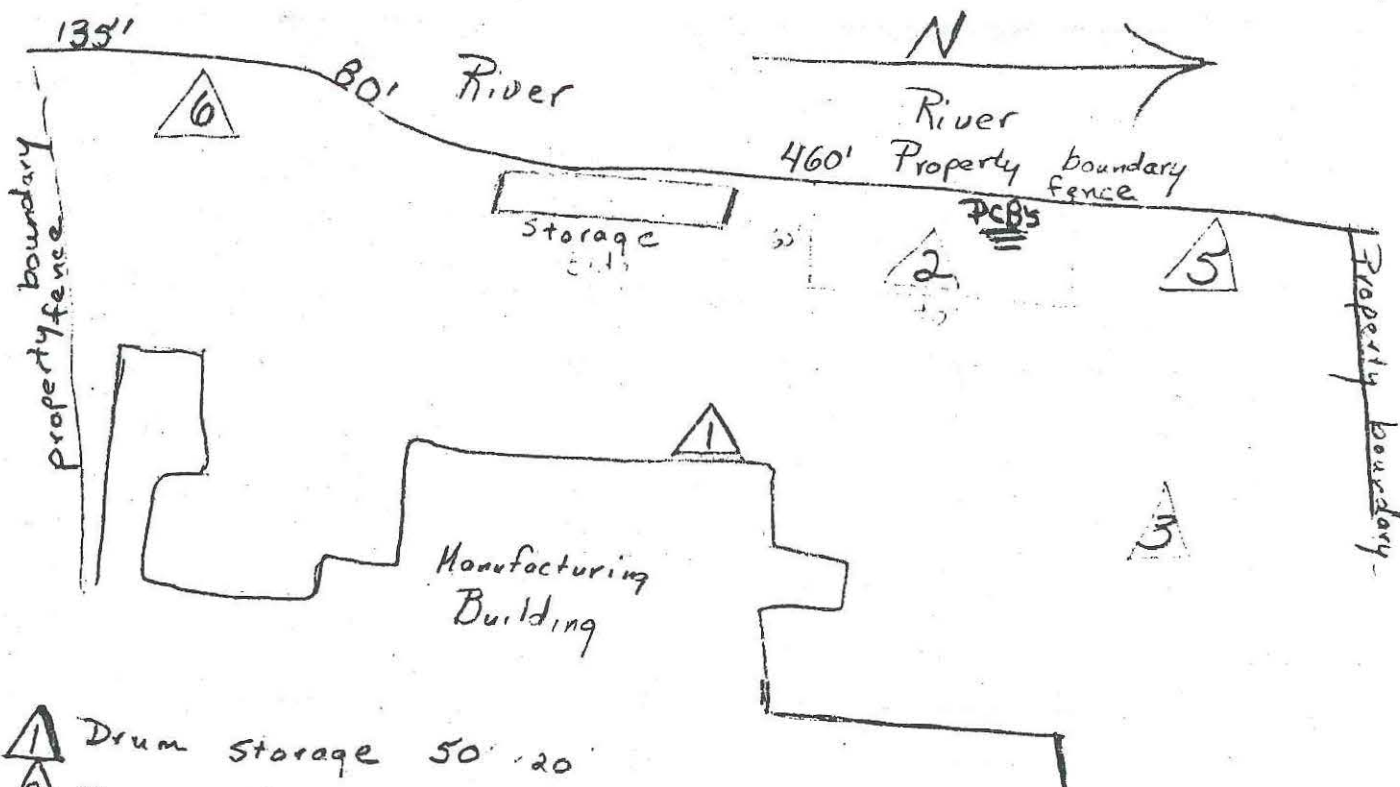
A. S.W. section of area $\triangle 6$.

B. Looks like lab chemicals-obviously not carefully controlled-not part of RCRA required operating record.

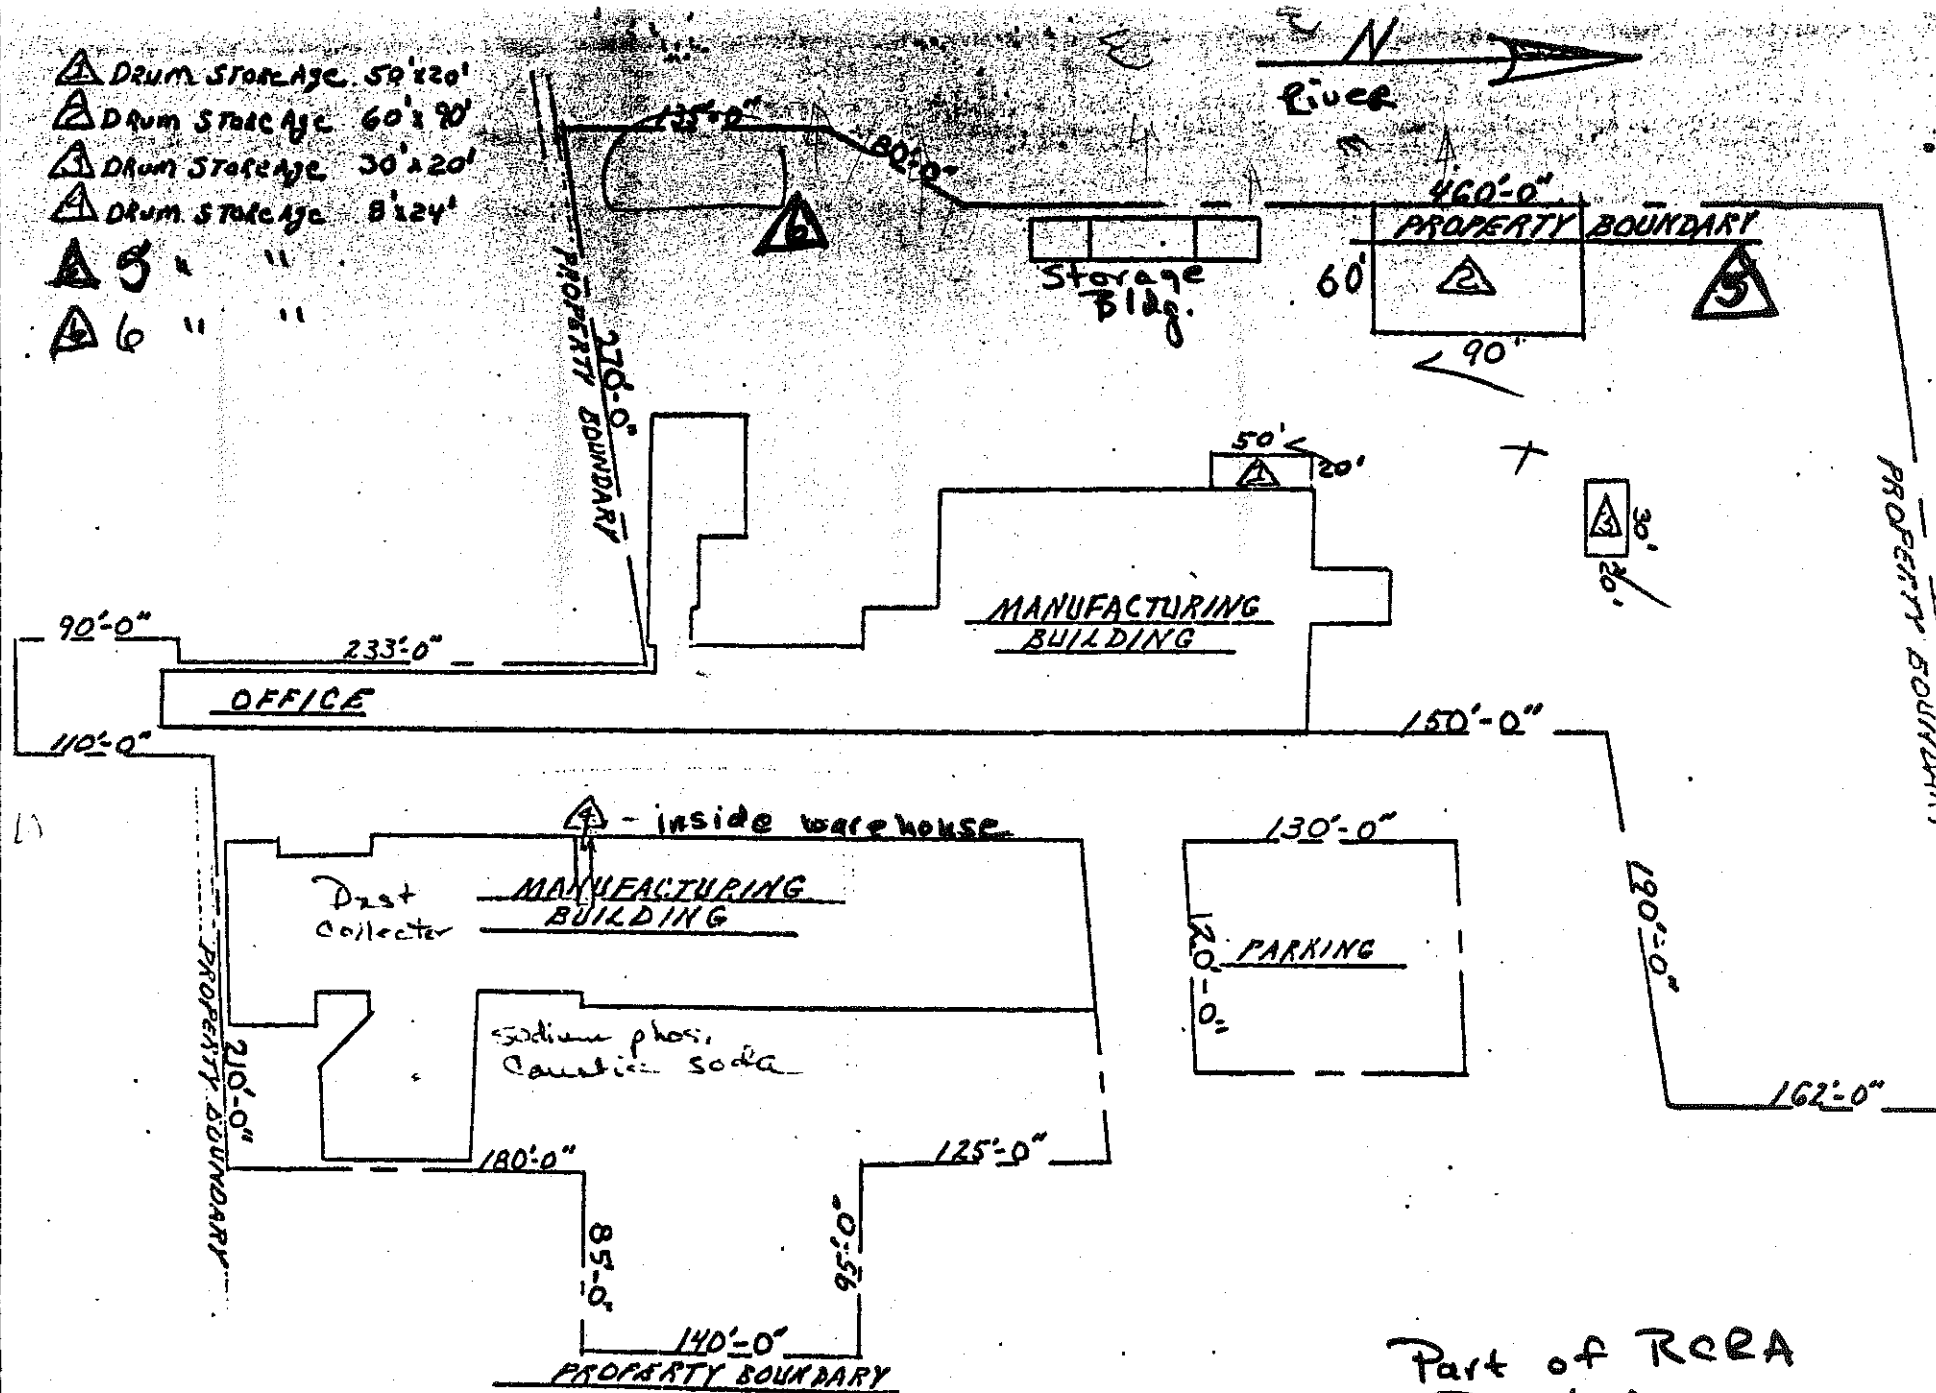
Part of RCRA
Part A - application

Hooker did not report storage areas $\triangle 5$ or $\triangle 6$ on their Part A - application of 10-8-80.

- △ DRUM STORAGE 50'x20'
- △ DRUM STORAGE 60'x20'
- △ DRUM STORAGE 30'x20'
- △ DRUM STORAGE 8'x24'
- △ 5 " "
- △ 6 " "
